Rio Tinto Water Engagement Initiative Nautley River Backwatering Investigation Results Draft Report, Rev. 1

Northwest Hydraulic Consultants Ltd.

December 15, 2023
Draft Report, Rev. 1
NHC Reference 3006714

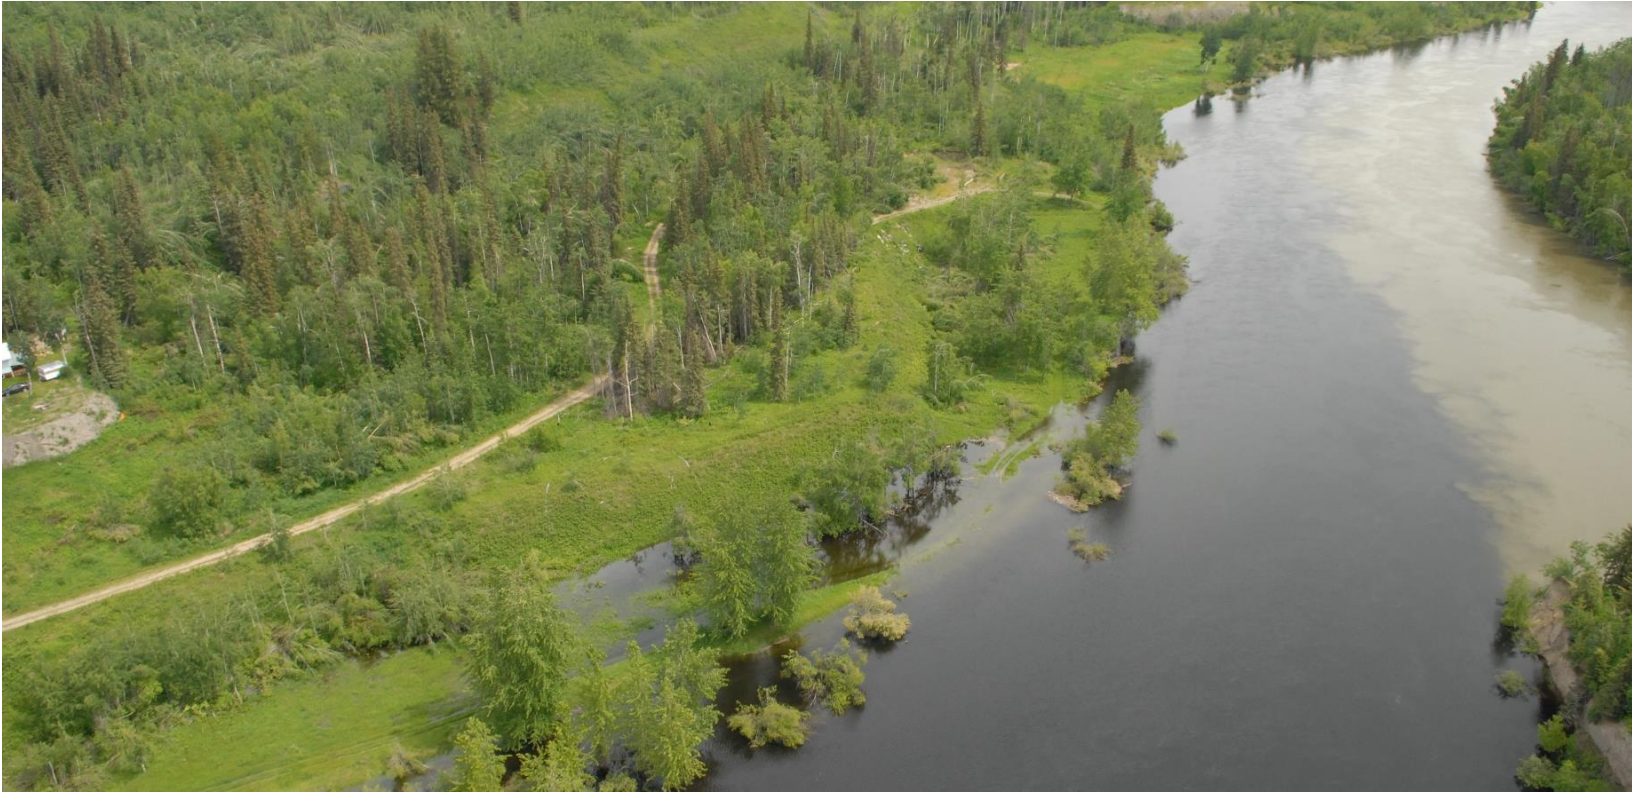
Confluence of the Nechako and Nautley rivers. **Photo source:** Mike Miles and Associates, 2007

Photo 6.1 Photo of the confluence of the Nechako and Nautley rivers taken on June 26, 2007, showing backwatered conditions on the Nautley River. 19

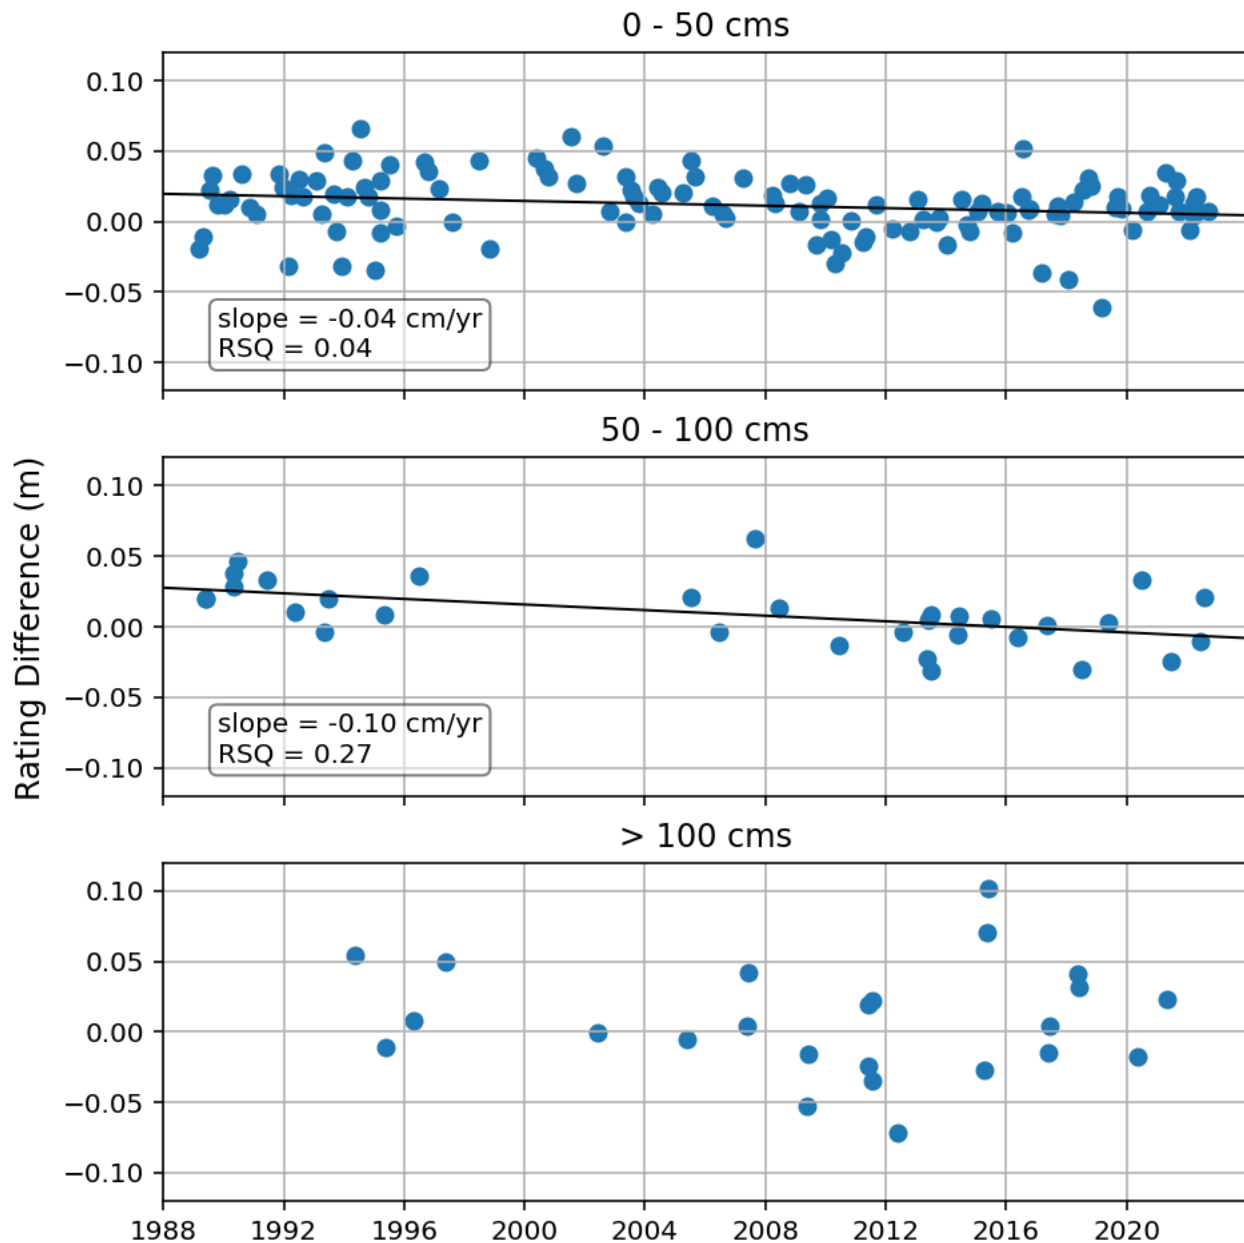
Figure 5.5 Specific gauge analysis for WSC station Nautley River near Fort Fraser (08JB003) binned by discharge intervals. Plotted points represent WSC discharge measurements by year and the deviation from the stage-discharge rating curve (m). Trendlines are shown where the trends are statistically significant [$p < 0.05$]. Note that the data have been truncated to exclude points prior to 1988 and above a threshold value of +0.15 m to highlight subtle changes in recent years; for the full dataset, see Figure 6.1.

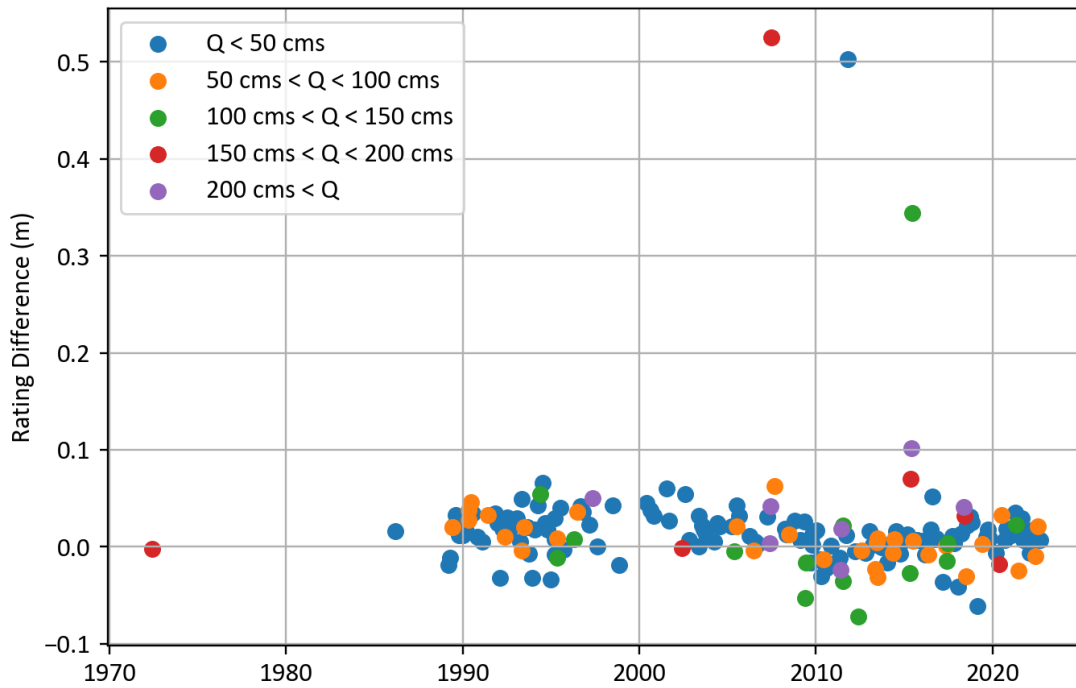
Figure 6.1 Specific gauge analysis for the WSC station Nautley River near Fort Fraser (08JB003). The plotted points represent WSC discharge measurements (m^3/s) by year and the deviation from the stage-discharge rating curve (m). Ranges in flow are colour-coded.

Aerial imagery collected by M. Miles and Associates Ltd. on June 26, 2007, a timing which roughly corresponds to the 2007 data point on Figure 6.1, also shows backwatered conditions on the Nautley River (Photo 6.1). The backwatered conditions can be inferred from the photo due to the relatively flat-water surface that is seen to extend from the confluence of the two rivers at the bottom left side of the image upstream into Fraser Lake at the top right side of the image. Under typical, non-backwatered conditions, a marked drop in the water surface elevation occurs as the water flows out of Fraser Lake and down over the Nautley River rock weir (Photo 5.1).

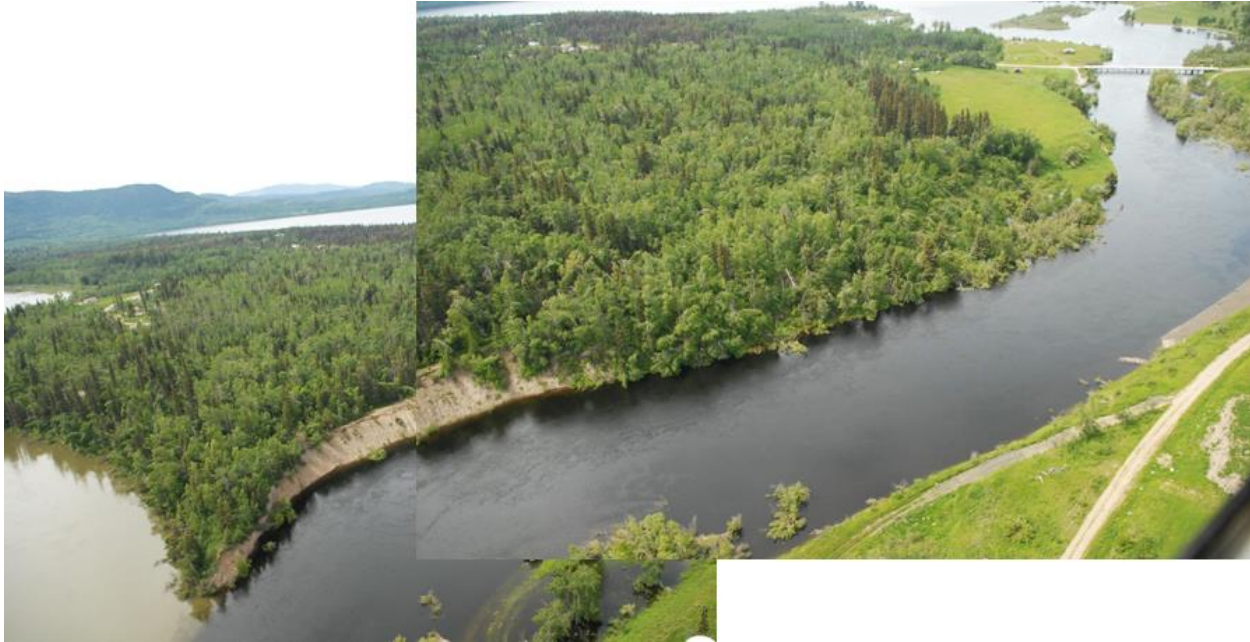
Photo 6.1 Photo of the confluence of the Nechako and Nautley rivers taken on June 26, 2007, showing backwatered conditions on the Nautley River. The discharge at WSC Nechako River below Cheslatta Falls (08JA017) and Nautley River near Fort Fraser (WSC 08JB003) was approximately 548 m³/s and 169 m³/s, respectively. The Nechako River is seen on the left, the Nautley River is on the right, and the photo is facing upstream. Source: M. Miles and Associates (2007b).

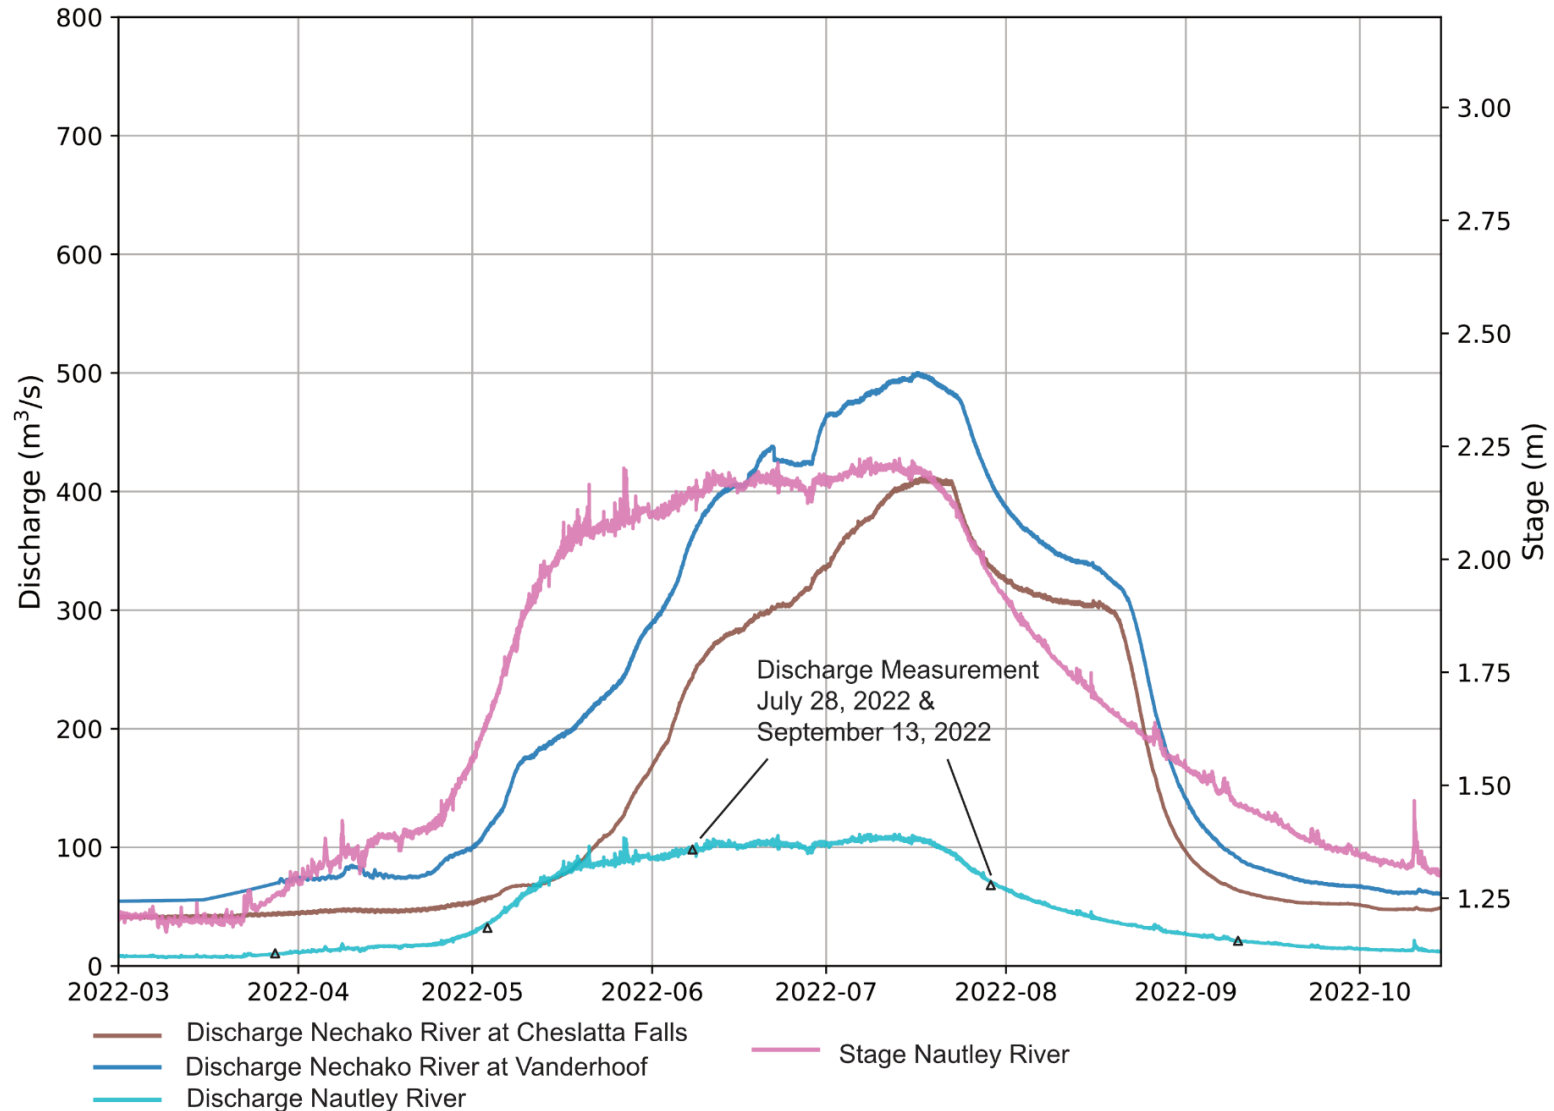
Figure 6.6 Discharge data from the high-water event in 2022 showing no discernable rise in water level (stage) on the Nautley River and demonstrating this event did not cause backwatering. Note, data since 2021 are preliminary, and Nautley River data are at an hourly timestep.

For comparison, Figure 6.6 presents plots for the stage and discharge records during the 2022 high-flow event, when discharge reached over 400 m³/s in the Nechako River below Cheslatta Falls (08JA017) and flows in the Nautley River were approximately 100 m³/s (Table 6.1). Despite the relatively high flows on the Nechako River and moderate flows on the Nautley River, these flow conditions did not appear to

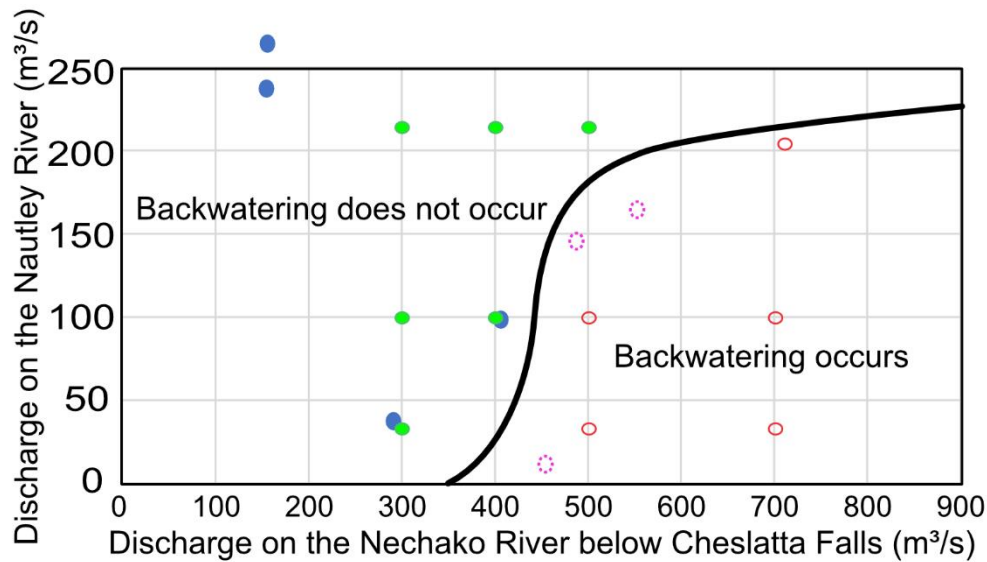
Figure 6.7 Illustration of discharges on the Nautley and Nechako Rivers that did (dashed purple circles) and did not (solid blue ovals) cause backwatering, overlaid on model results described in Section 6.4. The green solid circles represent model runs that did not experience backwatering, while the red open circles represent model runs that did show backwatering.

Figure 6.7 combines these observations and illustrates the observed flow events summarized in Table 6.1, along with the model results described in Section 6.4. The figure illustrates how backwatering of the Nautley River can be produced when the discharge of the Nechako River exceeds a threshold condition relative to the discharge of the Nautley River.

To improve confidence in the delineation of the line separating backwatering from non-backwatering conditions (Figure 6.7), NHC recommends modelling additional flow scenarios close to the threshold conditions. Our team modelled the Nautley weir based on the T&T Surveys Ltd. survey profile in 2017 (Swiftwater Consulting, 2017); additional surveying may be conducted to update and refine the weir geometry in the model. Additionally, the existing hydraulic model does not include the Nautley bridge, located at the outlet of the lake, which could be included in the model to better simulate lake outflows. The model may also be extended to include Fraser Lake to better evaluate flood levels around the lake; this model extension would likely require bathymetric surveys within the lake. Finally, the model may be updated to include a precipitation runoff module to simulate lake inflows. Once backwatering occurs, outflows from Fraser Lake are delayed and flooding duration is increased. Additional modelling of the entire lake and inflows to the lake would be required to quantitatively evaluate the impact of backwatering on flooding around the lake.

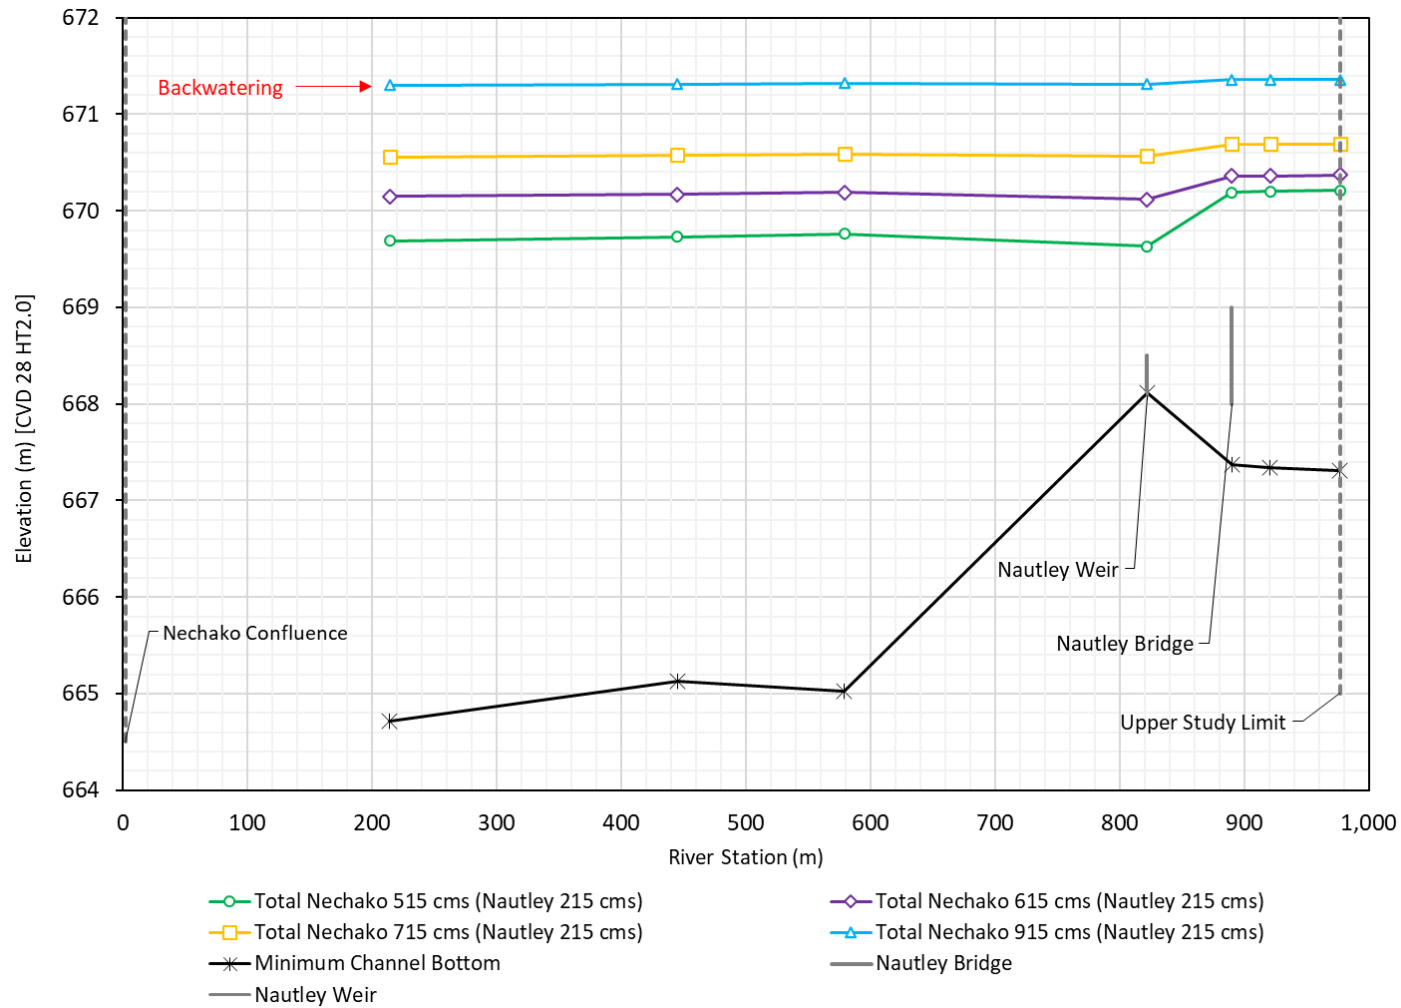
Figure 6.10 Simulated water surface profiles for the high-flow scenario on the Nautley River (215 m³/s). Nechako River inflows are varied, from 300 m³/s to 700 m³/s.

The simulated water surface profiles for the low-flow, moderate-flow, and high-flow scenarios on the Nautley River are presented in Figure 6.8, Figure 6.9, and Figure 6.10, respectively. These plots can be used to assess when backwatered conditions are present, which is shown as a flattening of the water surface profile from the confluence to the Nautley bridge. Under low-flow conditions in the Nautley River at 33 m³/s (Figure 6.8), backwatering occurs once Nechako River flows exceed approximately 350 to 400 m³/s, not including Nautley flows. Under moderate-flow conditions in the Nautley River at 100 m³/s (Figure 6.9), backwatering appears to occur once Nechako River flows exceed approximately 500 to 600 m³/s. Finally, under high-flow conditions in the Nautley River at 215 m³/s (Figure 6.10), backwatering occurs once Nechako River flows exceed approximately 900 m³/s, which represents an extremely high flow for the post-regulation period. All flows below approximately 900 m³/s do not appear to cause backwatering under the high-flow scenario on the Nautley River (at 215 m³/s).

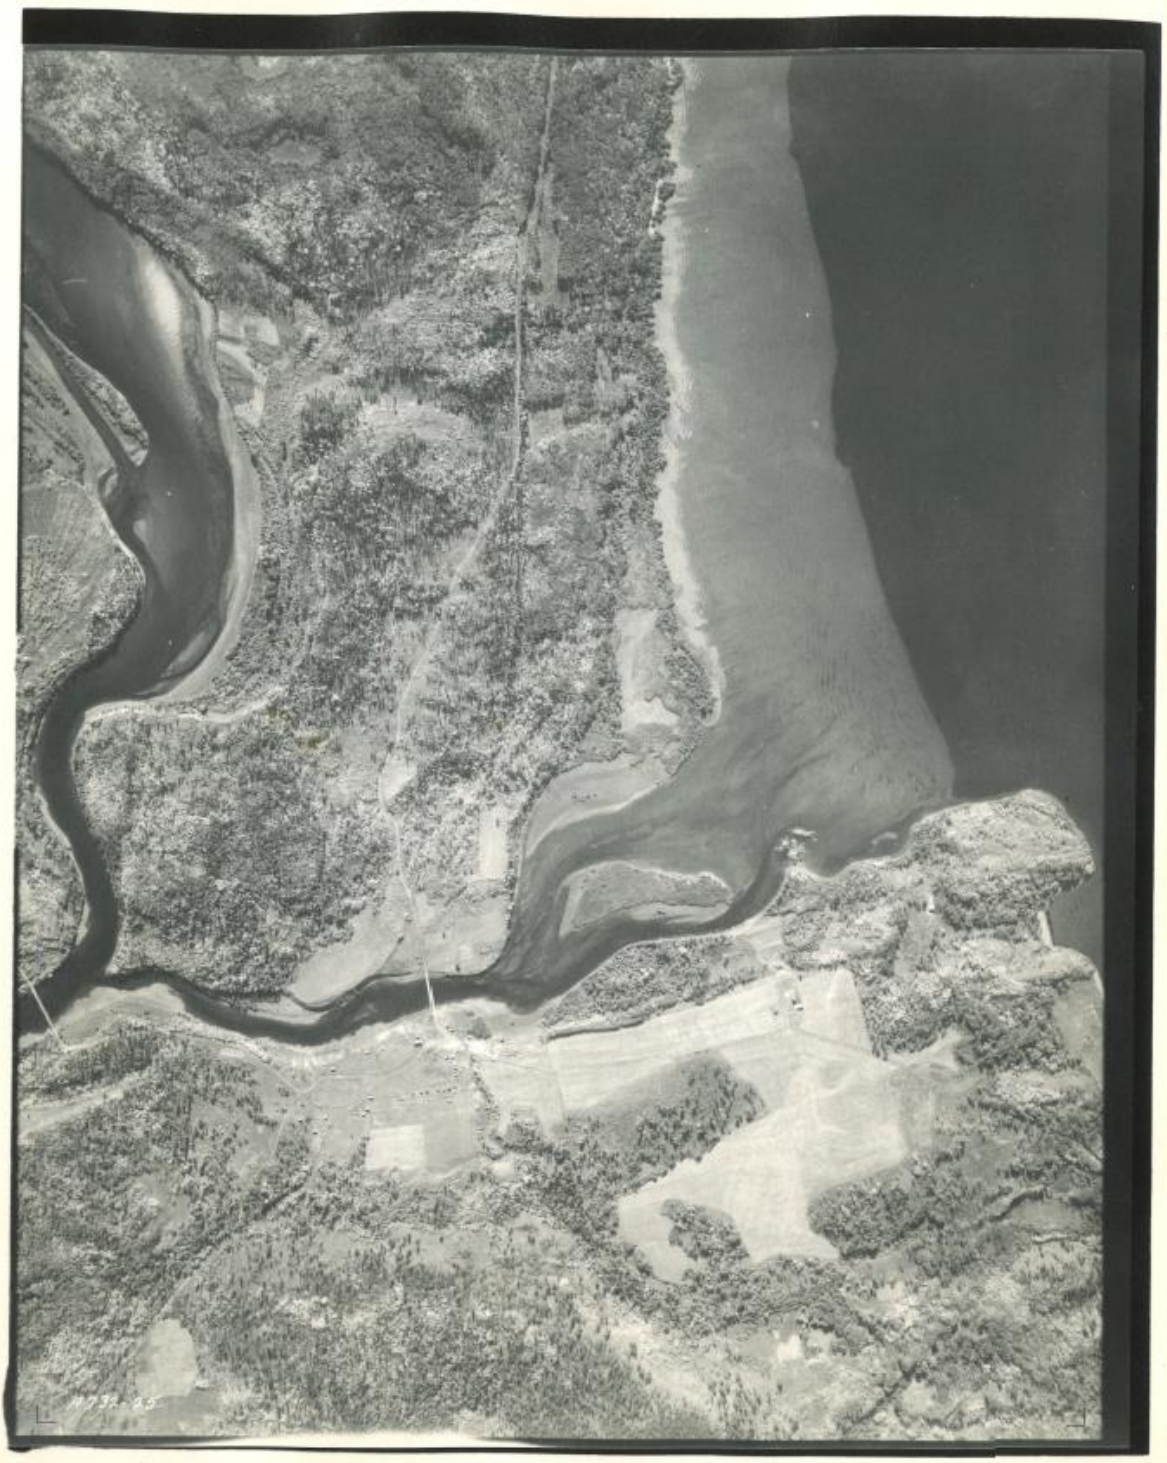
Photo A.1 1928 A732.25 air photo of the Nautley River flowing from Fraser Lake to the Nechako River.

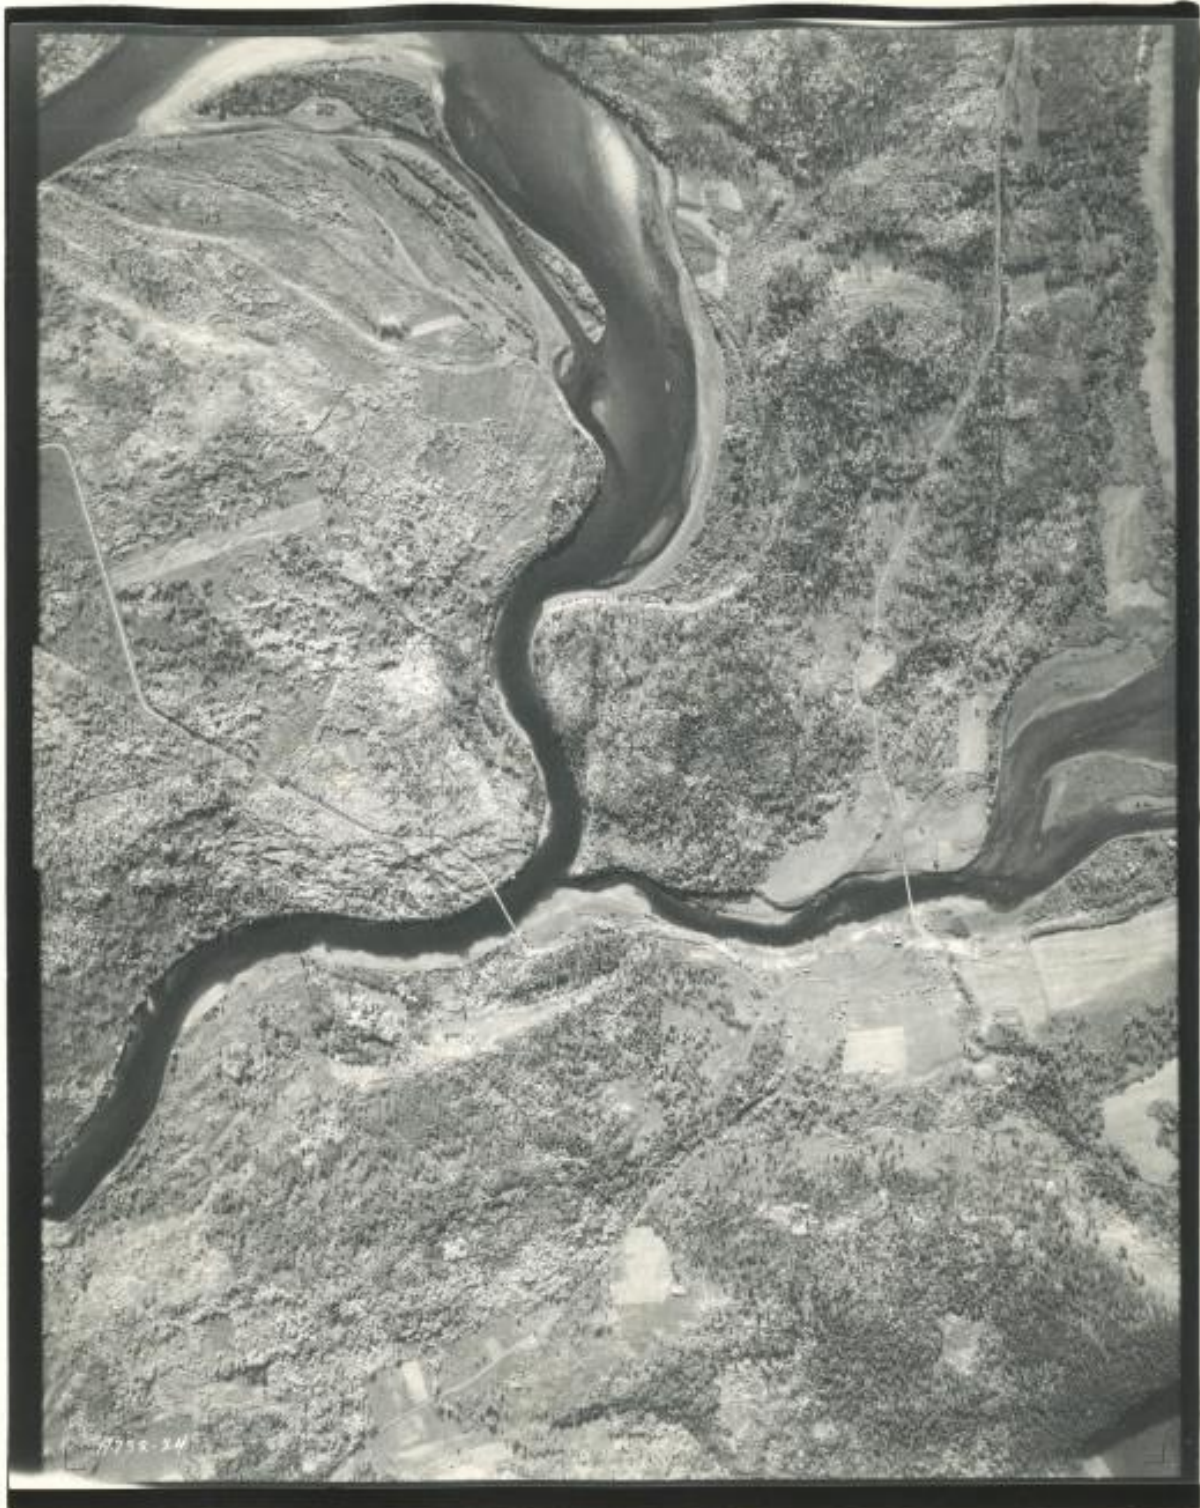
Photo A.2 1928 A732.25 air photo of the Nechako River and Nautley River confluence. The Nautley is the smaller waterway seen in the centre of the photograph.

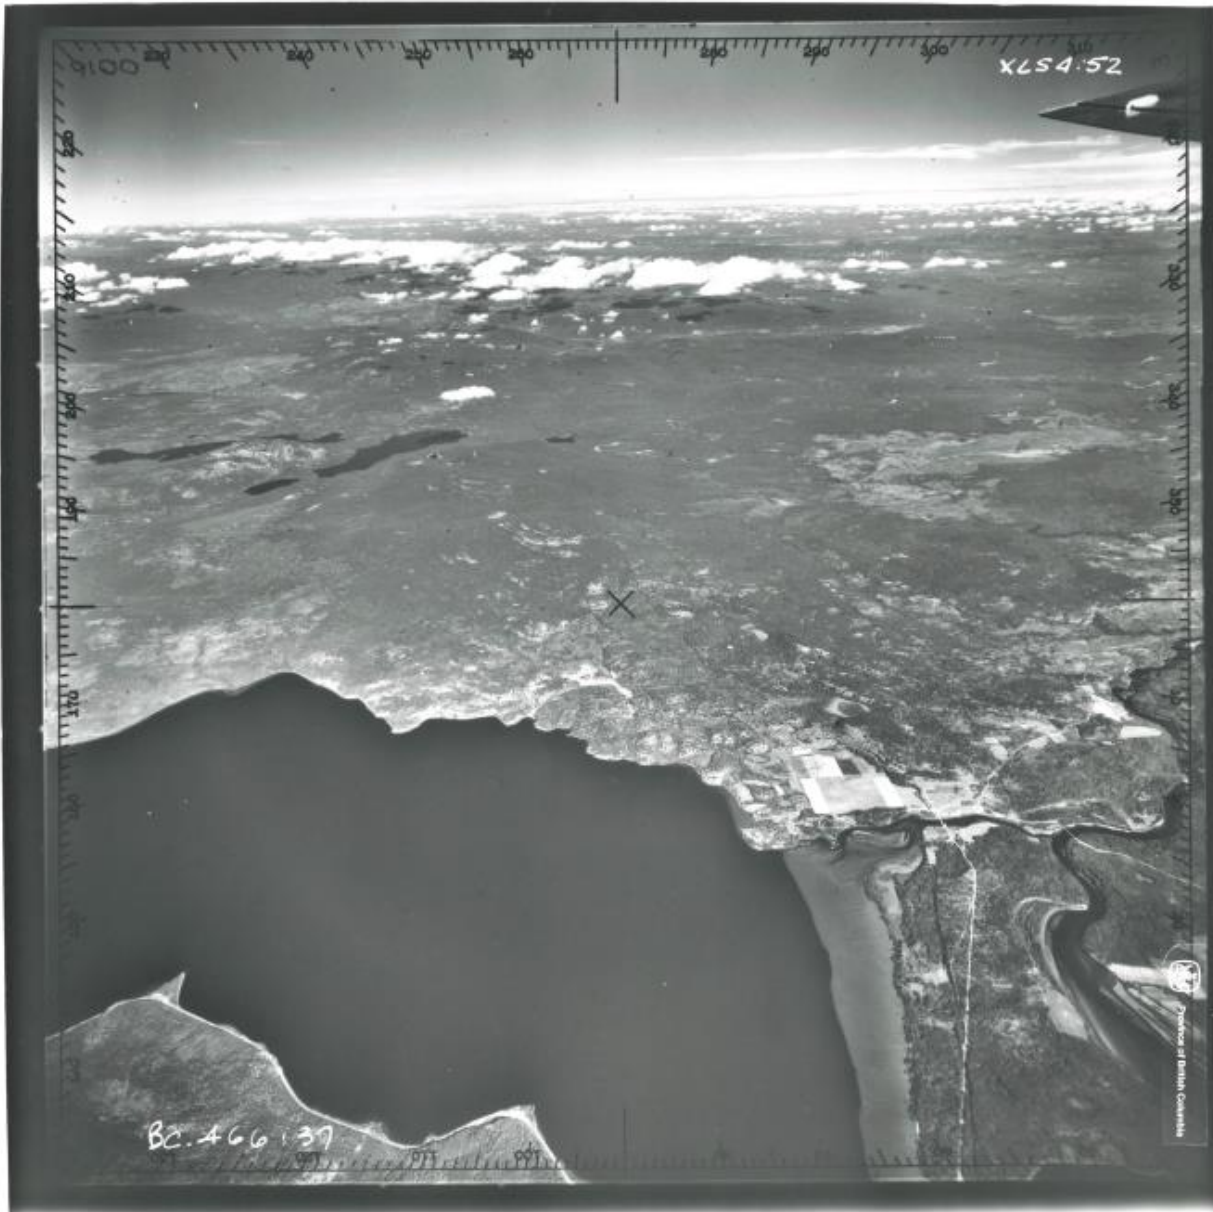
Photo A.3 1947 XL54.52 air photo of Fraser Lake and its outlet, Nautley River. The Nechako River and Nautley River confluence can also be seen in the bottom right of the photograph.

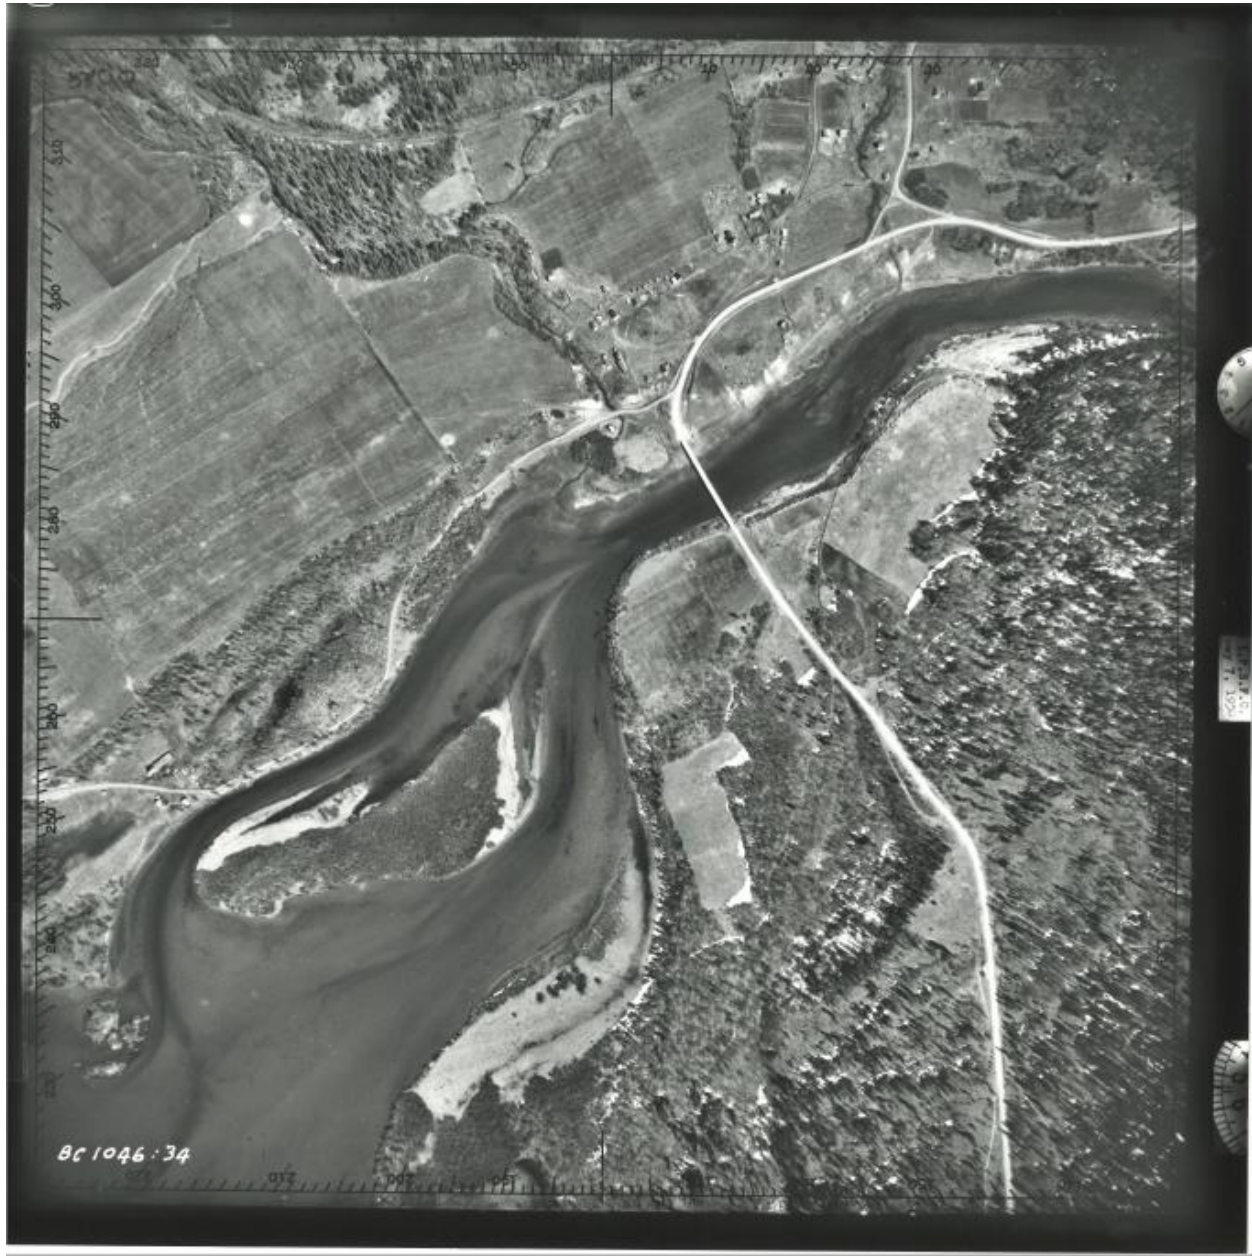
Photo A.5 1950 BC1046.34 air photo of the outlet of Fraser Lake, the Nautley River.

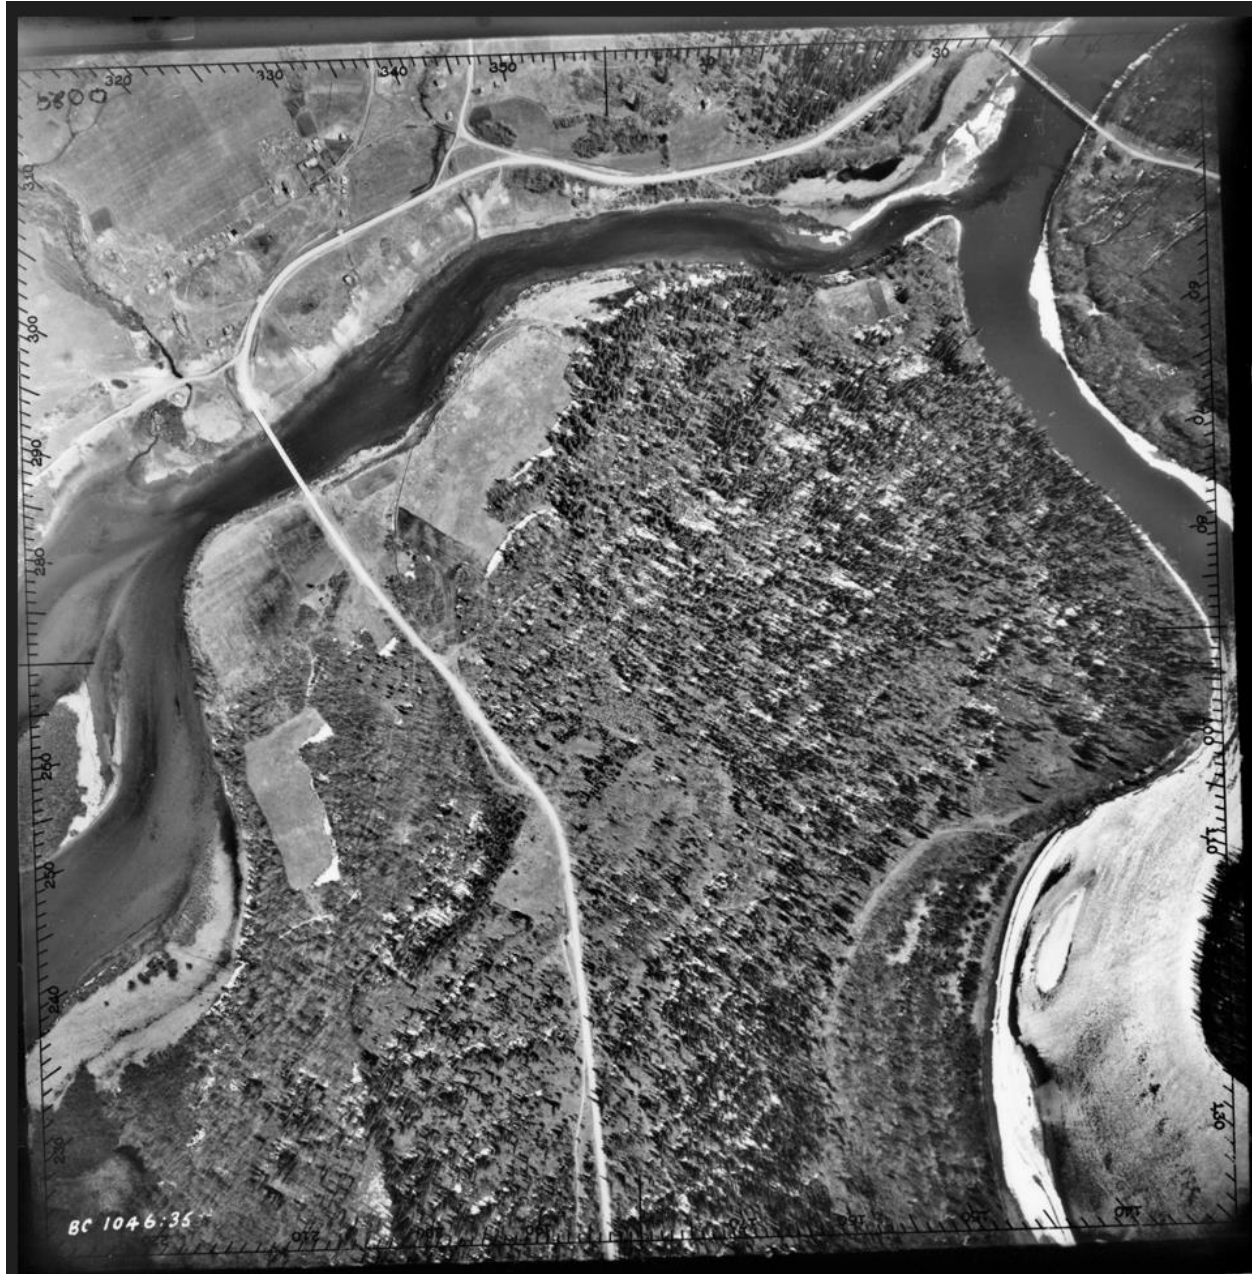
Photo A.6 BC 1046_357 historical aerial photograph of the Nechako River and Nautley confluence shown in the top right of the photograph (1950).

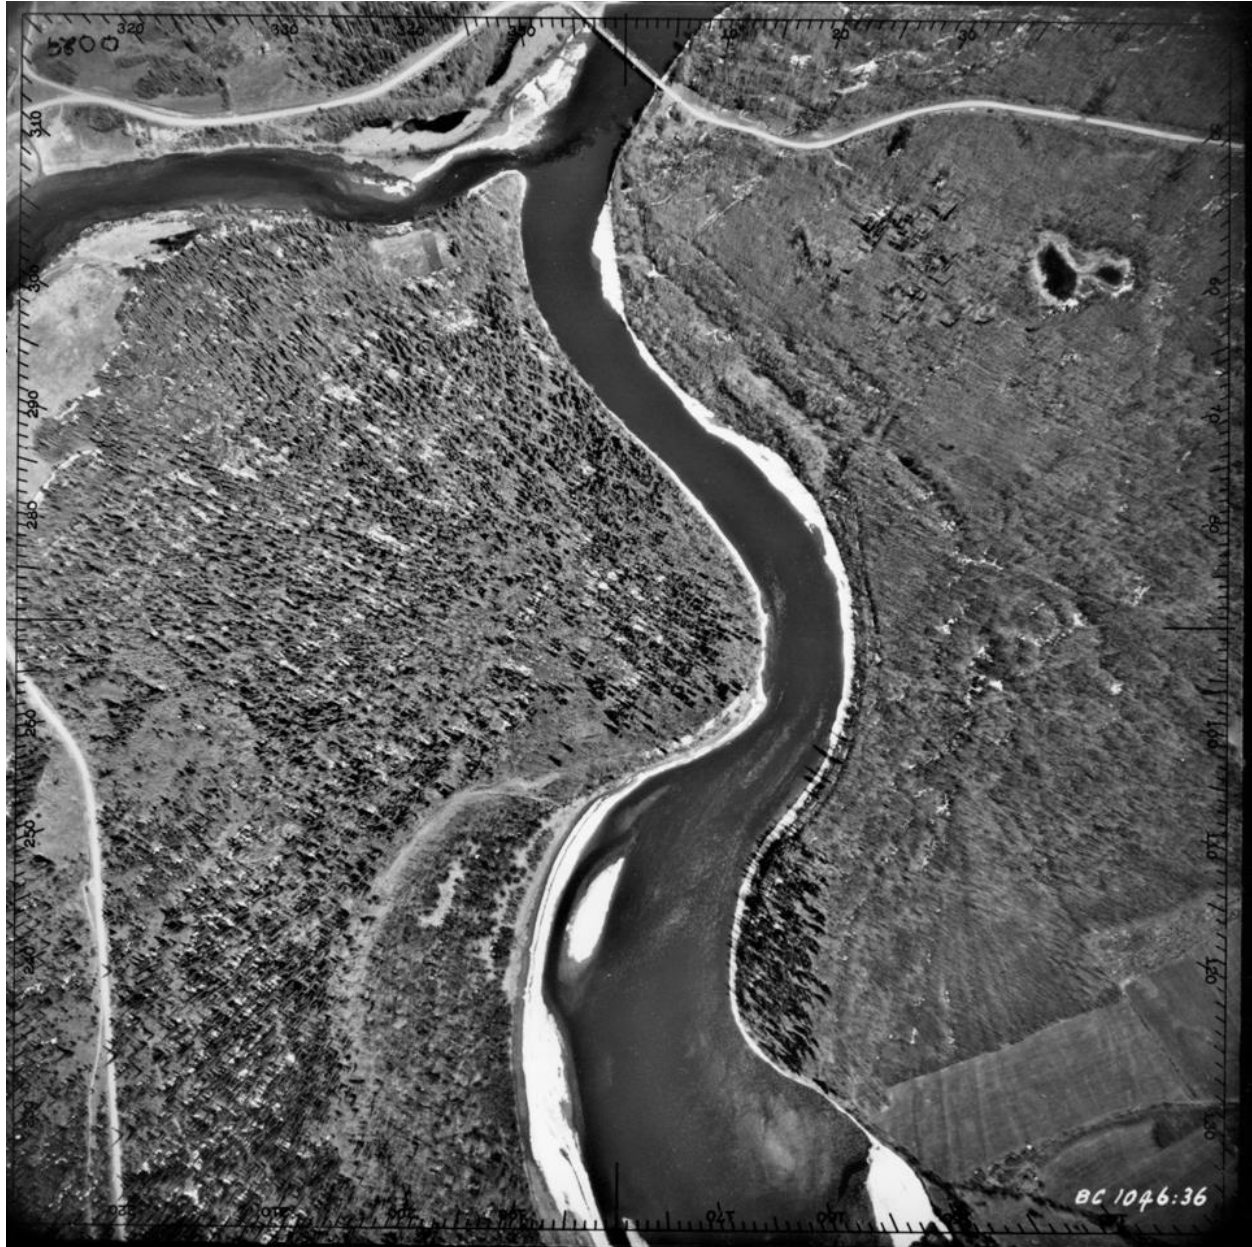
Photo A.7 BC 1046_36 historical aerial photograph of the Nechako River and the Nautley confluence shown in the top left corner of the photograph (1950).

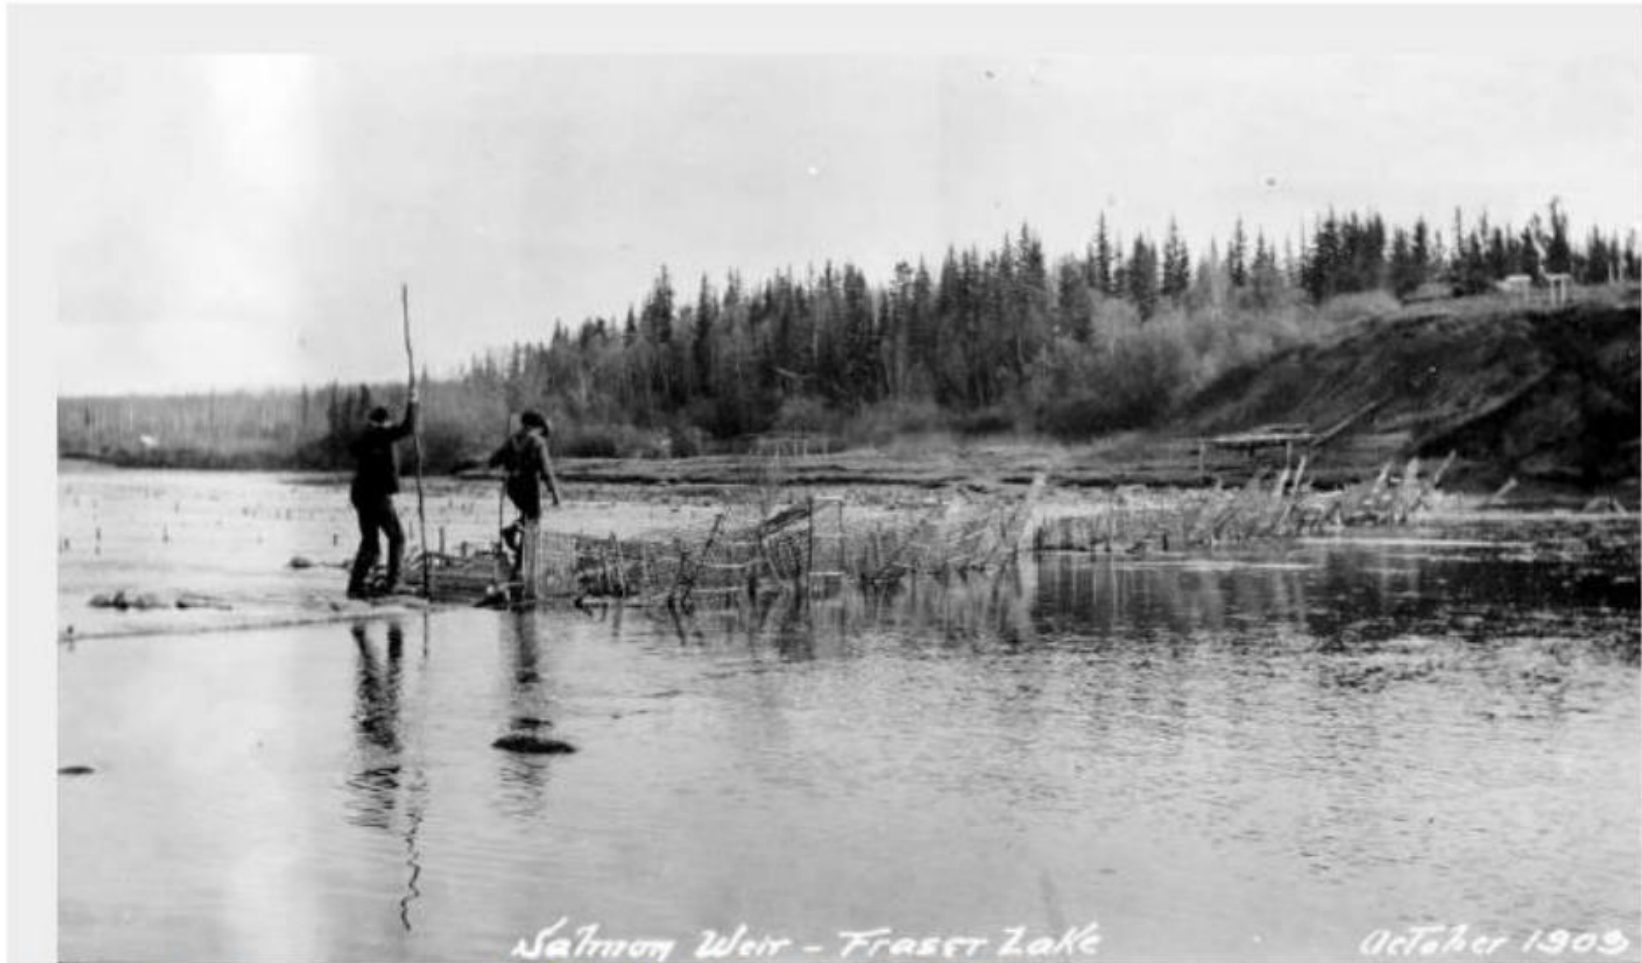
Figure 2 Salmon weir on the **Nautley** River in 1909 (5).
